Delivering the Nuclear Promise

Top Innovative Practice

DNP-TIP-2022-01

Acoustic Imaging to Improve Equipment Reliability and Cost Efficiency

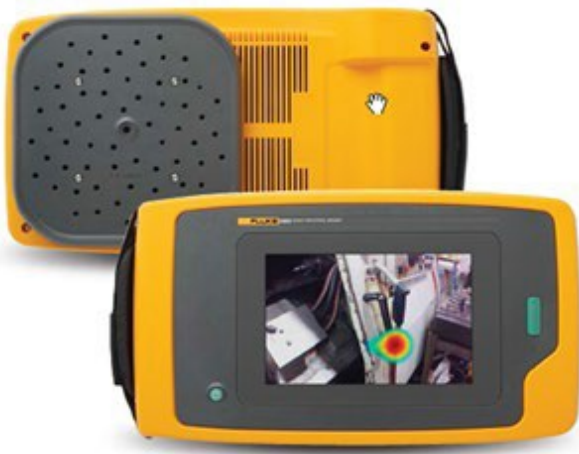
Graphic 1 - Acoustic Imager

To improve condition monitoring capabilities at Palo Verde Nuclear Station, an acoustic imaging device was identified and utilized to assess sound signatures within the plant that are indicative of minute leaks. The device has an array of highly sensitive microphones that can detect both audible and high frequencies humans can't hear. The device translates the audio frequencies into a visual heatmap overlaid with a digital image that pinpoints the area of leakage. Palo Verde has been utilizing the device to identify and repair numerous system leaks within plant systems including Safety Injection tanks (gas leaks), Feedwater Heaters (tube leaks), Instrument Air, Main Steam, and Steam Generation. The acoustic imaging device, used by experienced individuals, can readily identify low level leaks in a fast and efficient manner to quickly focus the station's repair efforts and restore the plant back to its optimal design configuration. EPRI has provided the industry with a number of guidance documents based on research done in the area of Acoustic Emission, including EPRI Technical Reports 3002009935 "Guidelines for the Use of Acoustic Emission and Passive Ultrasonic Techniques" and 3002020843 "Acoustic and Ultrasound Technology and Program Guide."

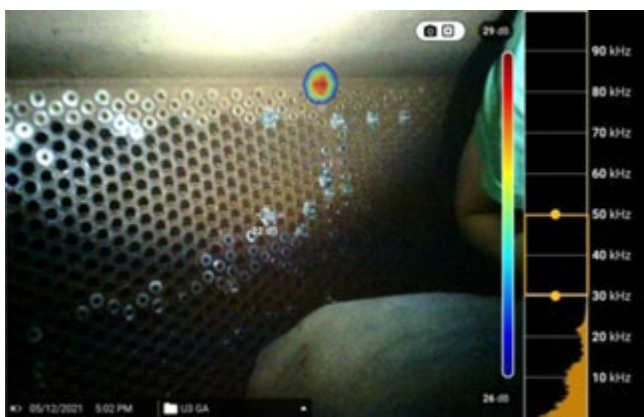
Graphic 3- Low Pressure Feedwater Heater Tube Leak

This process is far more efficient than other technologies, including smoke tests and helium detection. These methods required meticulous care going from tube to tube in heat exchangers, mapping and documenting findings. With the acoustic imagers an entire tube sheet can be assessed quickly to visually identify sources of leakage, expediting repairs and saving precious hours of power production.
