Delivering the Nuclear Promise

DNP-TIP-2021-09

Development and Demonstration of In-Situ Repair Method for Nuclear Fuel Dry Cask Storage Canisters

2021 Top Innovative Practice Winner

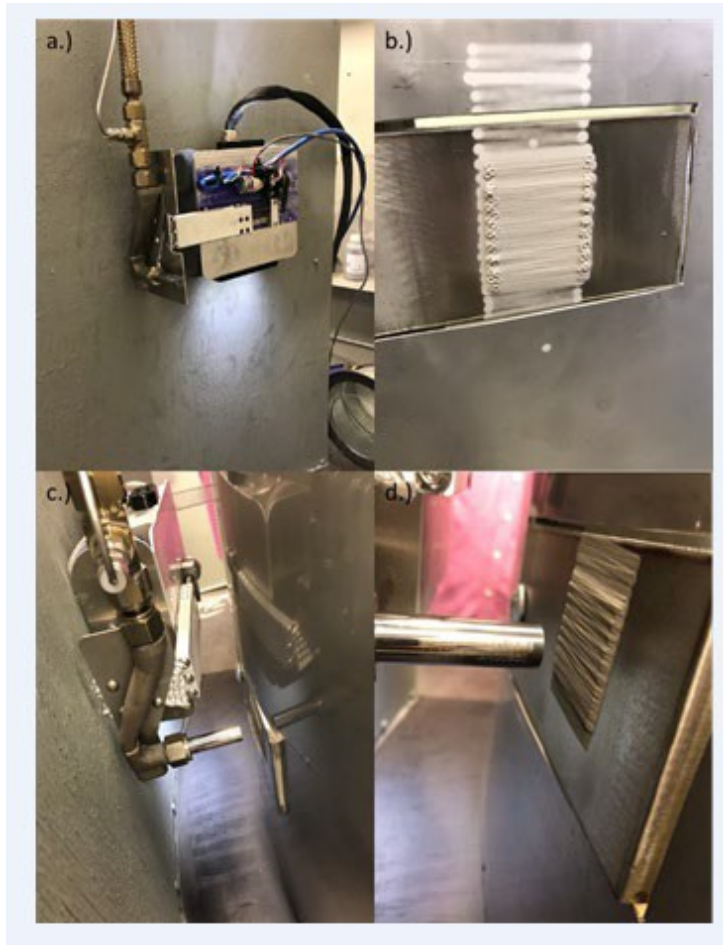
Graphic 1: https://fs10.formsite.com/neiform/files/f-20-49-14780757_IDScbxjA_Metallic_Overlay_testing_in_Test_Fixture.tif

After the repair nozzle was mated to the robot, testing was performed including mockup testing on a full-scale canister/storage module section at the vendor facility. After it was proved successful, all equipment was brought to SONGS where a demonstration repair was successfully performed on a test canister. The testing attracted a lot of attention in the industry and was observed by regulators, researchers, and peers.
